NASA/TM-2017-43; 7: 6

Emergency Locator Transmitter Survivability and Reliability Study

February 2017

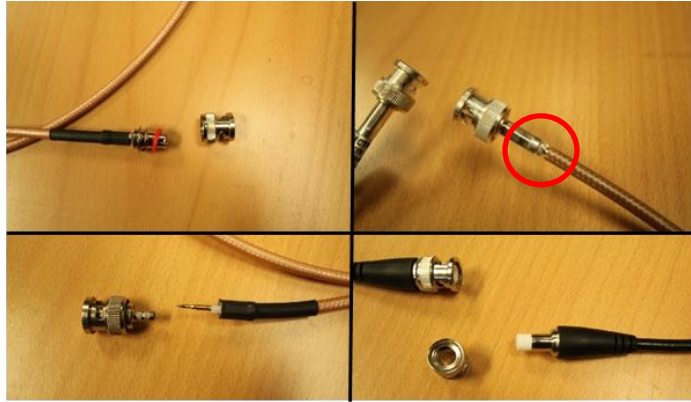
It was observed that vendor supplied cables manufactured in accordance with MIL-DTL-17 exhibited higher static strength characteristics than generic, unmarked cables by a wide margin. For example, the range of static strengths observed with MIL-DTL-17 cable systems was on the order of 80-100 lbf as compared to 20-30 lbf for the generic cables supplied by some ELT vendors. Representative failures are shown in Figure 9.

Figure 9. Antenna Cable Connector Failures from Strength Testing

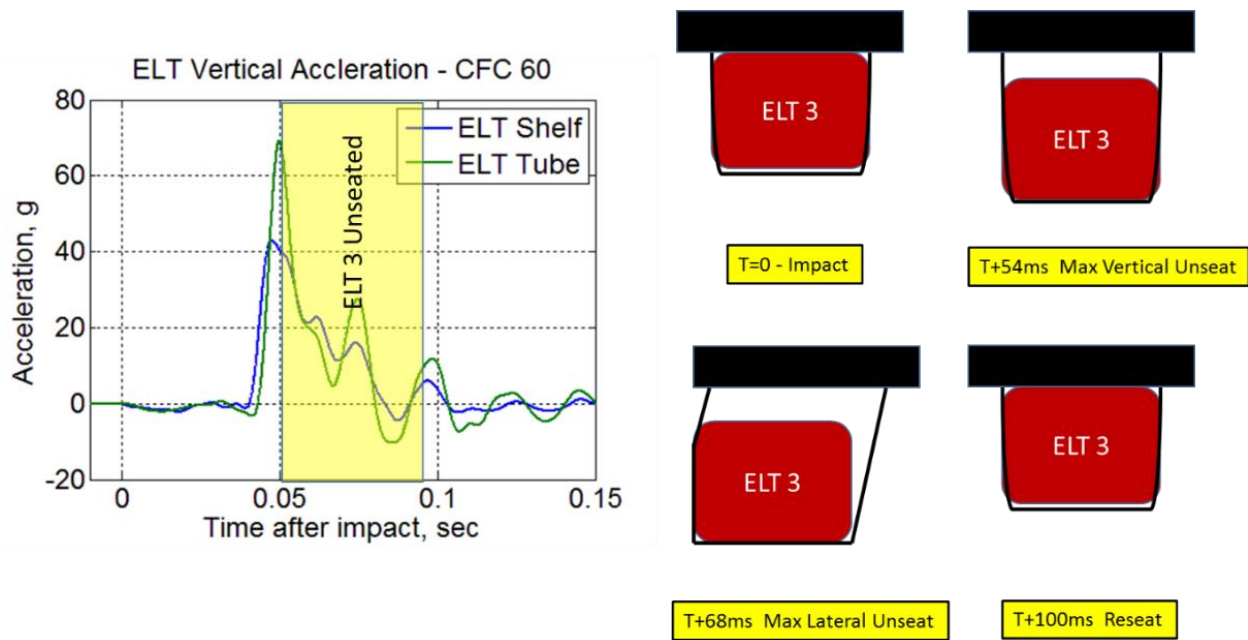
There was nominal structural responses from ELTs 1, 2 and 4 during the test, all of which utilized TSO-C126b compliant mounting systems. All units showed no signs of damage when reviewing the video or during post-test inspections. ELT 3, however, exhibited an unseating/reseating behavior as summarized in Figure 19. ELT 3 utilized a hook-and-loop style mounting system, but was brand new.

Figure 19. Hook-and-Loop Mounting System Behavior During TRACT 2

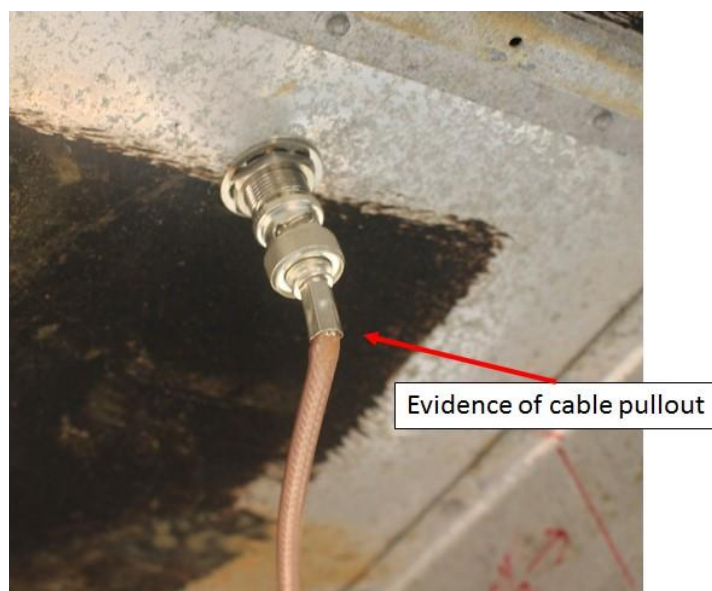
Closer inspection of ELT 4 showed that the antenna cable had partially pulled out of the end fitting at the antenna connection as shown in Figure 27. Although the installation of this particular system followed all requirements, it intentionally did not follow best practice in that the antenna and beacon were not co-located in the same airframe station, causing the antenna cable to cross the production break between the cabin and tail section of the fuselage. It is believed that the large deformation of this region during the crash test led to the cable connection failure.

Figure 27. Antenna Cable Damage Observed After Airplane Crash Test 2

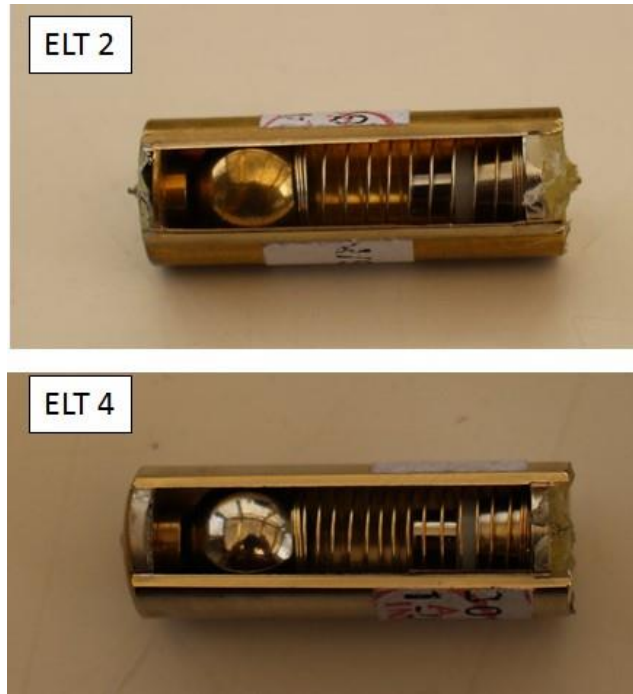
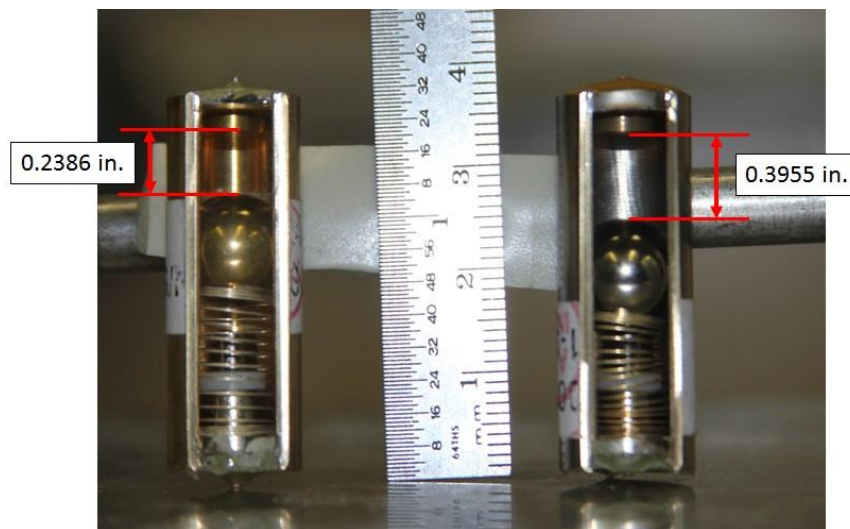
As shown in Figure 32, under 1-g vertical loading, the spring inside the g-switch on the right has collapsed to the point that the mass is making contact with the lead, resulting in a "closed" condition. However, the spring inside the g-switch on the left is apparently stiffer and the switch remains in the "open" condition. Given these differences, it should be expected that each switch should perform differently under dynamic loading conditions, which is consistent with crash test performance observations.

Figure 31. Cutaway View of G-switch Assemblies

Figure 32. G-switch Variation Between ELT 2 (left) and ELT 4 (right)

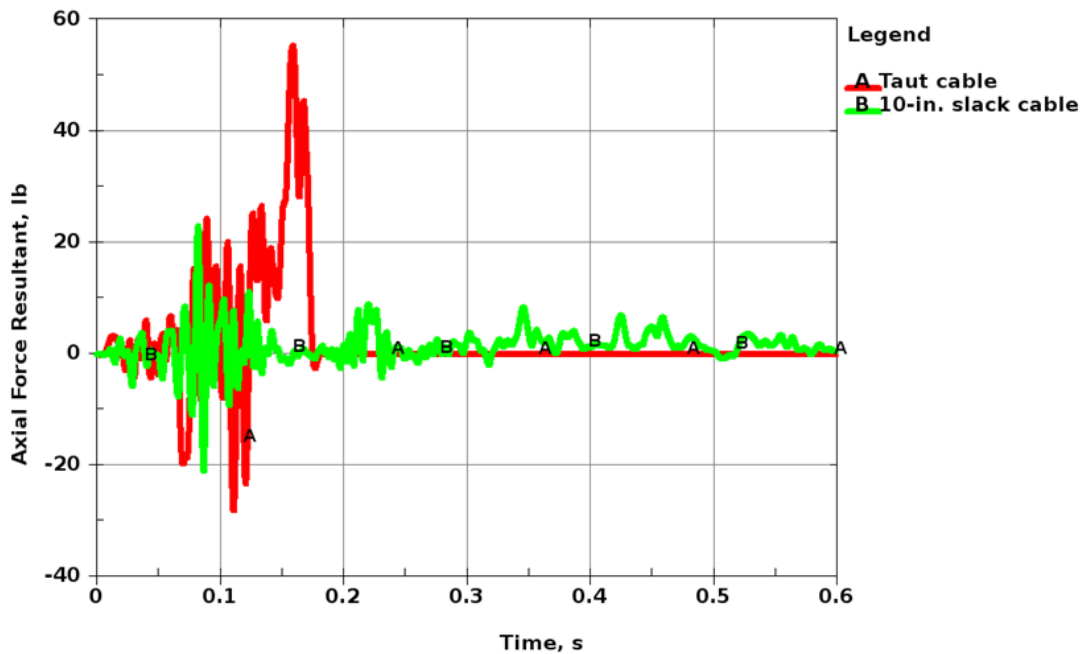
It was found that following the best practices described in [31] contributed positively to reducing the forces experienced by the antenna cable connections to acceptable levels. Figure 36 shows the predicted tensile load experienced by the antenna cable connector for two different cable installation schemes undergoing the same crash event. The simulated crash conditions were similar to those tested with the third airplane described previously, but with a rigid (e.g. concrete) impact surface instead of soil.

Figure 36. Comparison of Dynamic Cable Connector Forces for Taut and Slack Conditions
